**Washington Department of Ecology  
Hazardous Waste & Toxics Reduction Program  
Compliance Report**

**Site:** **EcoLab Inc.** **EPA/State ID Number:** **WAH000056860**  
Inspection Date: April 23, 2019  
Site Contacts: Michael Carette-Meyers, Regional Manager – SPS Western US  
Phone: (253) 306-6828 Email: [michael.carette-meyers@ecolab.com](mailto:michael.carette-meyers@ecolab.com)  
Site Location: 401 East Alexander Ave, Lot #1  
Tacoma, WA 98421  
Website: <https://www.ecolab.com>  
At This Site Since: April 2015  
Current Site Status: Large Quantity Generator

**Inspection Summary:**

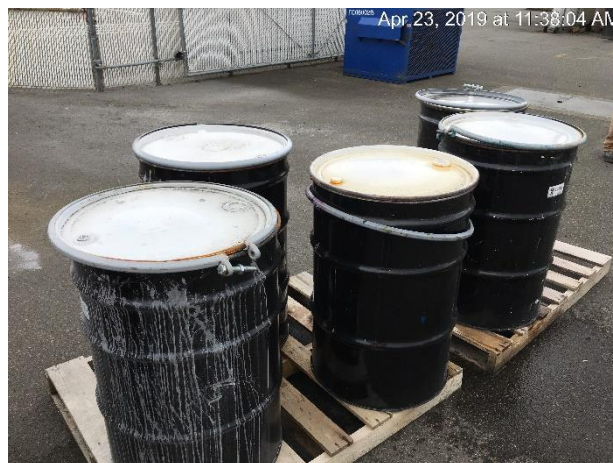
Photo 3

Southeast Corner of Lot

Close-up of containers shown in photo 1.

- One empty portable diesel tank used to fuel equipment in remote locations. They plan on sending it to another Ecolab location to be reused.
- Equipment trailers staged for deploying equipment at off-site facilities and vessels.
- Eight 55-gallon black metal containers with unsecured lids (photos 1 – 3). The containers were not marked with the contents and were stored on top of wood pallets. Michael Carette-Meyers explained that these were from the clean-up of the aluminum phosphide fire that occurred on March 19, 2019. Michael Carette-Meyers said that these containers were the responsibility of the National Response Corporation (NRC) and was unsure of their contents or how they would be managed.

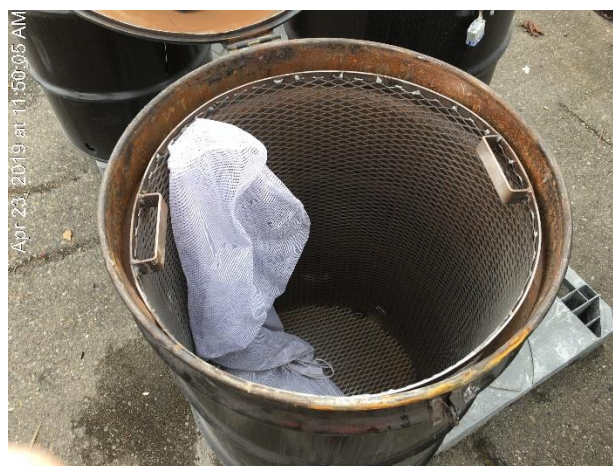
Photo 4

Southern Corner of Lot

Contents of one of four 55-gallon black metal containers shown in photo 5. This container was being used to dry deactivate aluminum phosphide at the time of the inspection.

- Four 55-gallon black metal containers with holes located near their bottom and customized lids to aid in the dry deactivation of partially spent aluminum phosphide fumigant (photo 5). Two of the containers were labeled as “Danger/Peligro, Poison, under fumigation with Weevil-cide; USED – DEGAS” and were currently being used to dry deactivate aluminum phosphide pellets (photos 4 and 6). The other two containers were labeled as “Empty – not in use” and were empty at the time of the inspection. The aluminum phosphide pellets are left in the dry deactivation process for a minimum of seven days. Two socks worth, or about 10 pounds of aluminum phosphide pellets, were present in both of the active containers. Michael Carette-Meyers said this was representative of a typical amount of aluminum phosphide that is placed in the deactivation process.

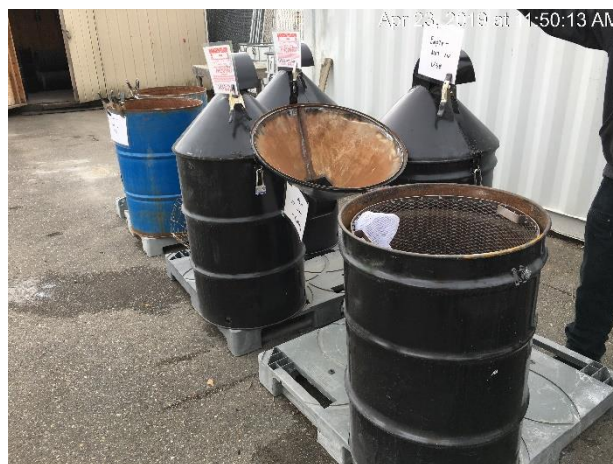
Photo 5

Southern Corner of Lot

Four 55-gallon black metal containers with holes located near their bottom and customized lids to aid in the dry deactivation of partially spent aluminum phosphide fumigant.

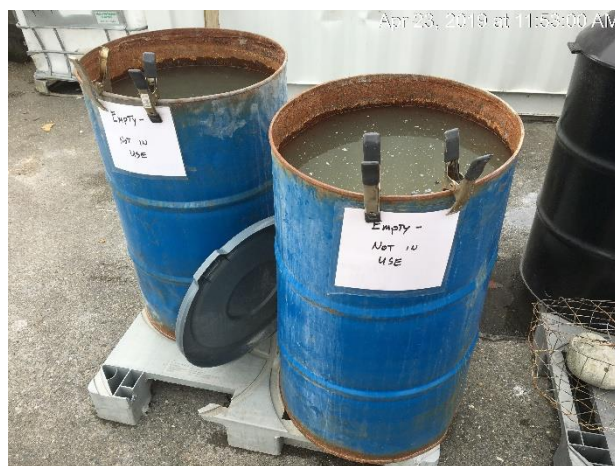
Photo 7

Southern Corner of Lot

Two 55-gallon open-top blue metal containers that were each full (approximately 6 inches of freeboard) of water with a 2% soap/surfactant solution. Both containers were labeled as “Empty – not in use” and were not located within secondary containment.

- Two 55-gallon open-top blue metal containers that were each full (approximately 6 inches of freeboard) of water with a 2% soap/surfactant solution (photo 7). Both containers were labeled as “Empty – not in use” and were not located within secondary containment. Michael Carette-Meyers explained that after the aluminum phosphide pellets are removed from the dry deactivation process, the pellets are placed in these two containers to begin the wet deactivation process. The aluminum phosphide pellets are left in the wet deactivation process for a minimum of seven days. Michael Carette-Meyers said this water/soap solution is reused continuously, but that the wastewater could be discharged to the sanitary sewer if needed.
